SERVICE REPORT

CUSTOMER:
Fishery Group DMCC
LOCATION:
Las Palmas
WORK ORDER / CUSTOMER PO :

VESSEL/FACTORY/SITE:
Fishing Force
ENGINEER:
David Lasso
PROJECT No.:
29531/420000265

ST90,SN90 and TP90 hydrophones installation

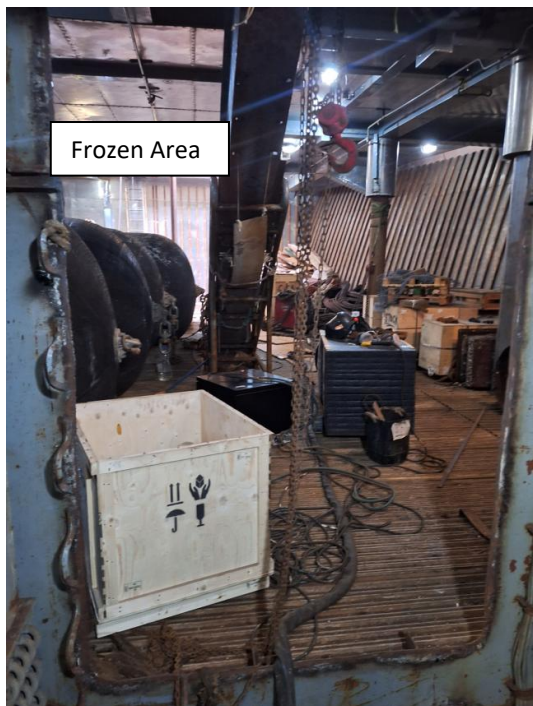
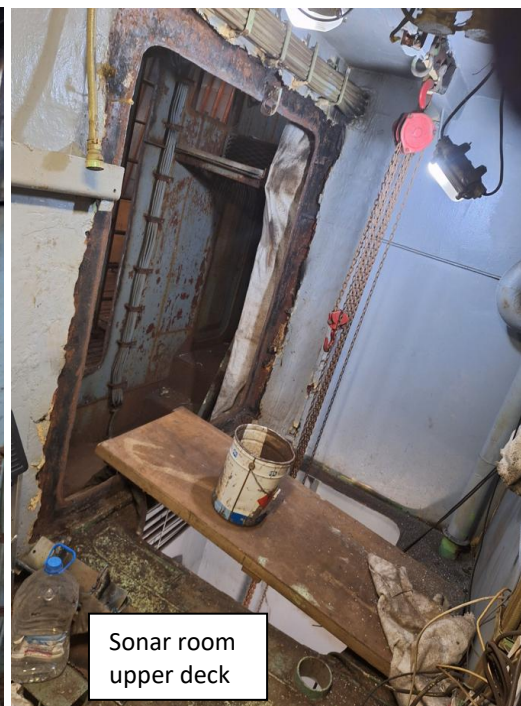
Sonar has been installed in sonar room. To proceed with the installation, it was necessary to cut some parts of the room because there was not enough space to proceed with the maneuver. The hull unit was installed through the frozen area to the sonar room.

Works done on sonar room to install the hull unit (upper deck)

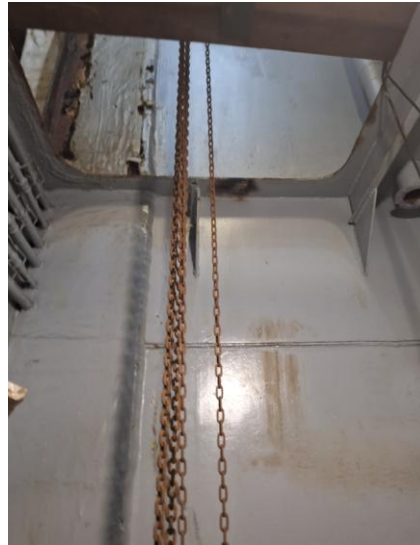
Works done on sonar room to install the hull unit (lower deck)

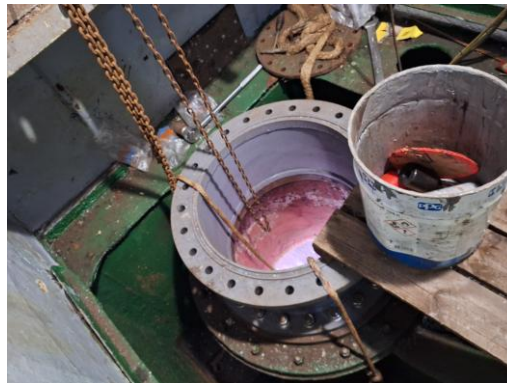
Flange adapter installed

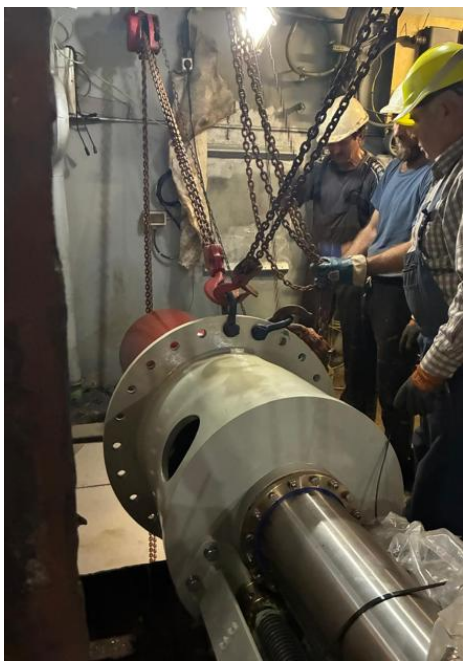
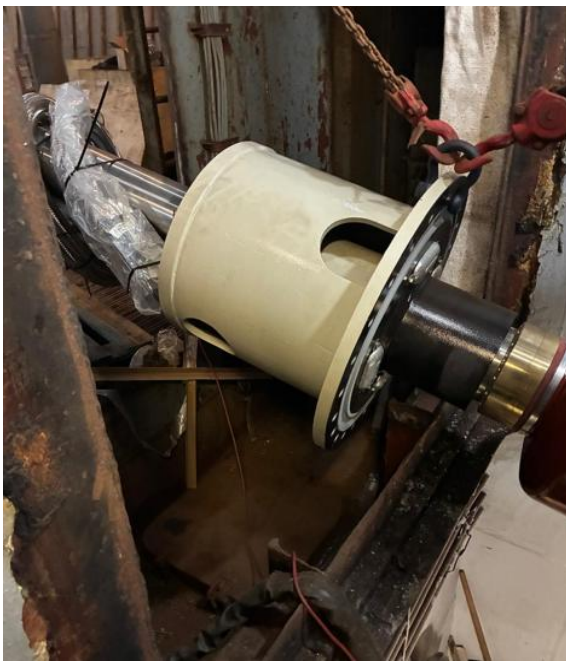
Maneuver to install system

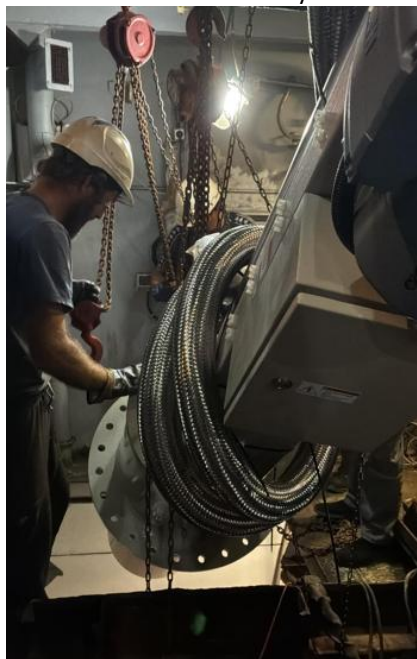
Maneuver to install system

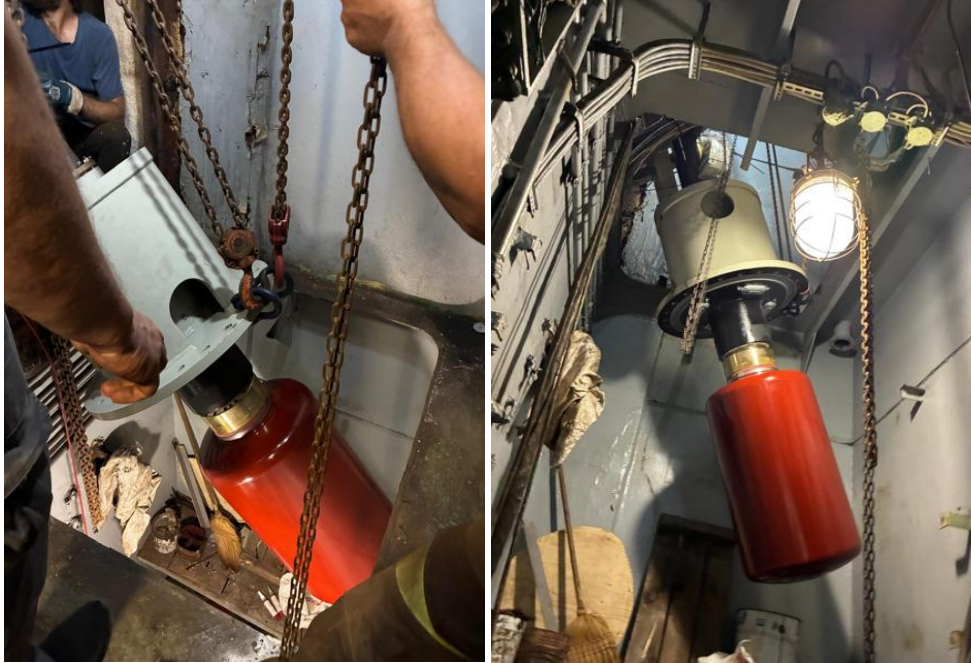
Maneuver to install system

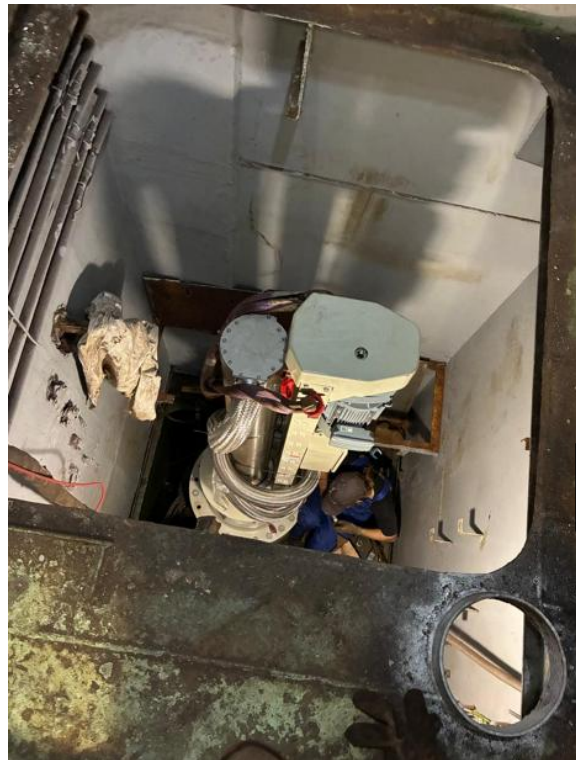
A protection for hull unit cable has to be installed

Unit Installed

-Protection has to be installed in hull unit/transducer cable

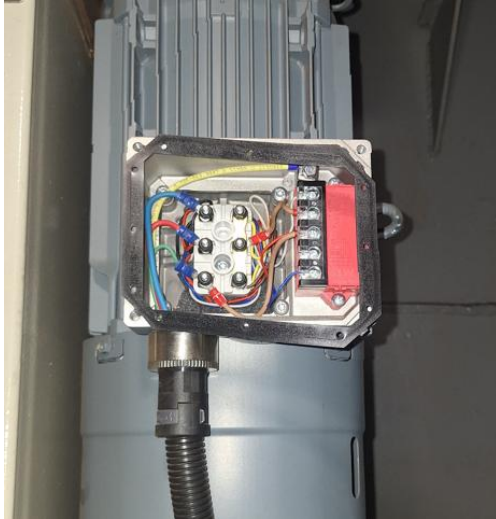
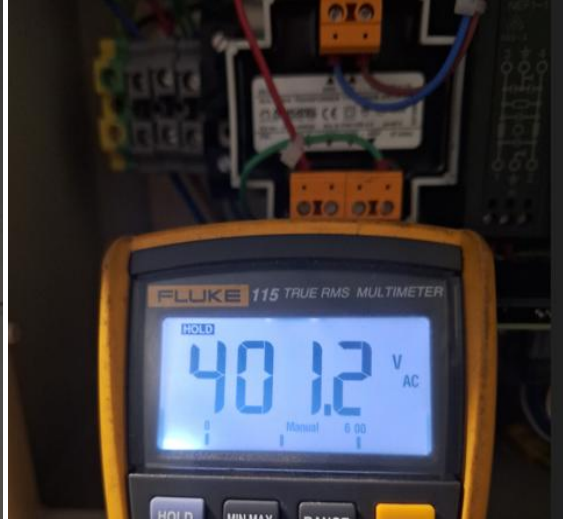
Motor setup according to voltage input

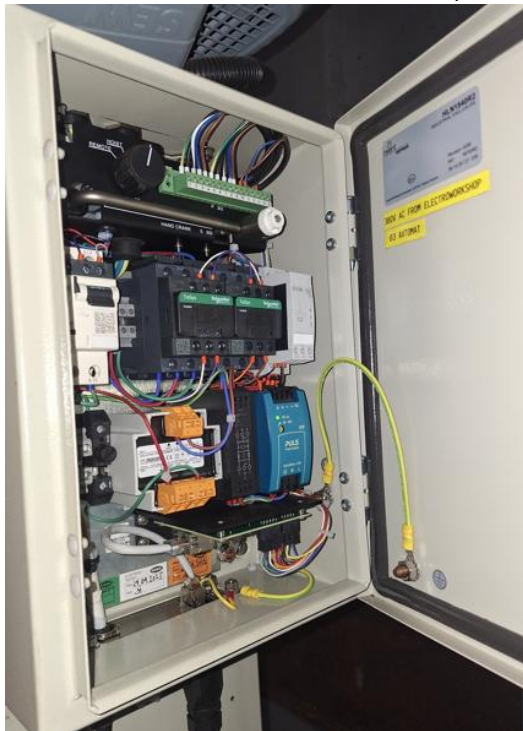
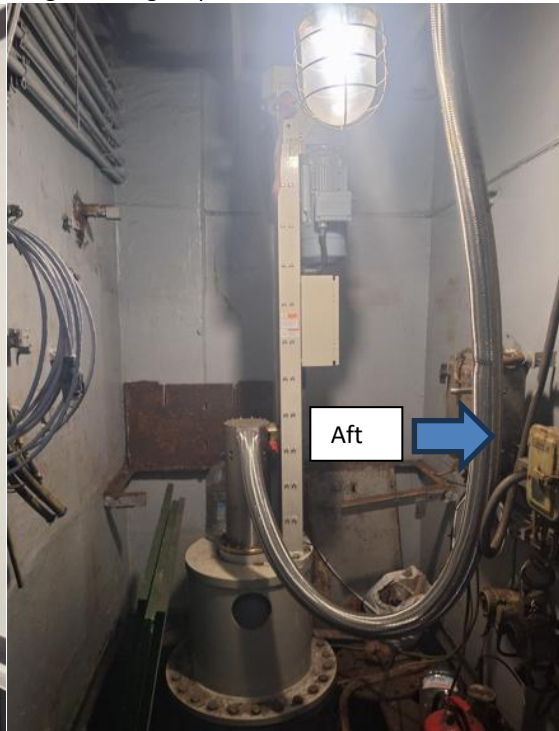
System installed

-Hull unit: Brackets not installed. Must be installed. One bracket installed from stdb to hull unit and second from Bow to Hull unit.

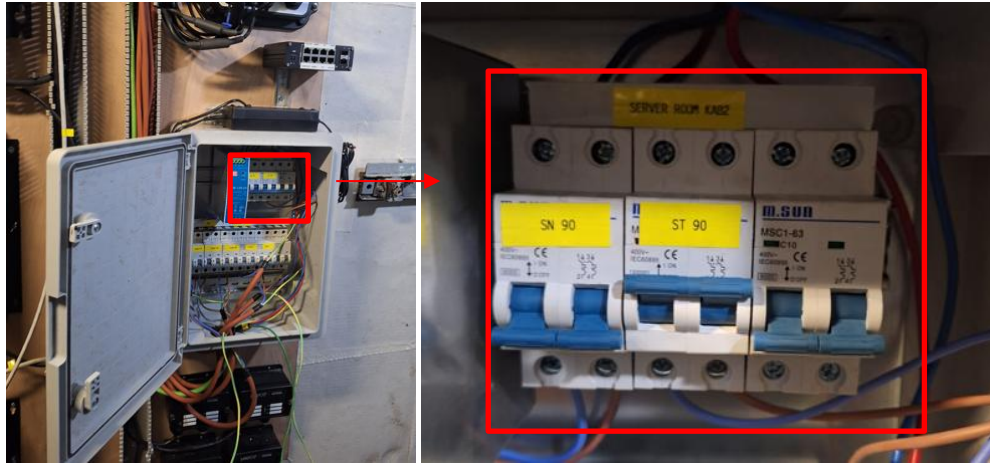
Power box for TRU

-TRU: Ground cable is without nut, has to be installed.

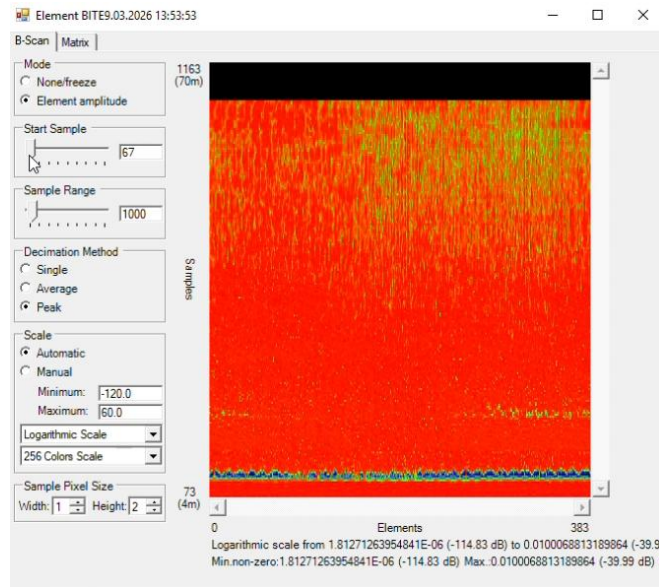
Bite activator

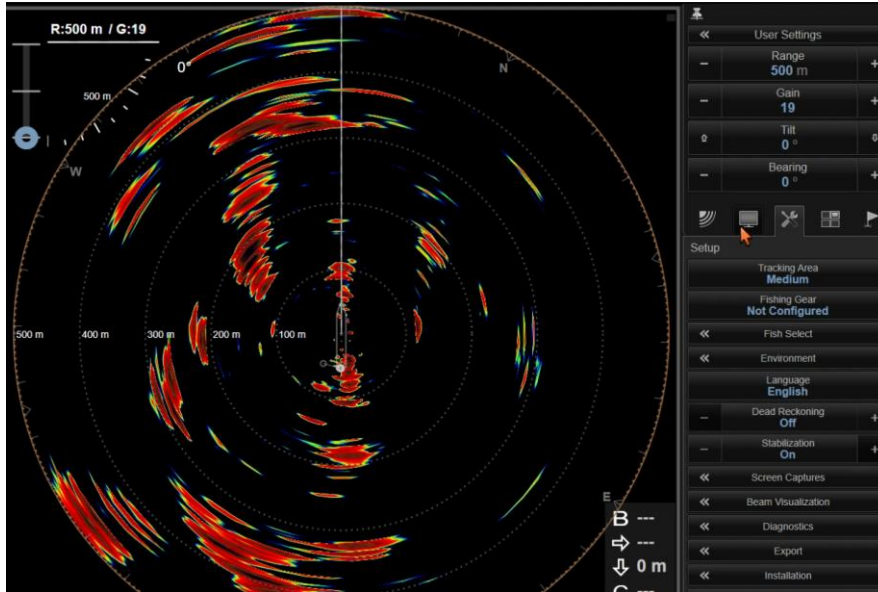
System working

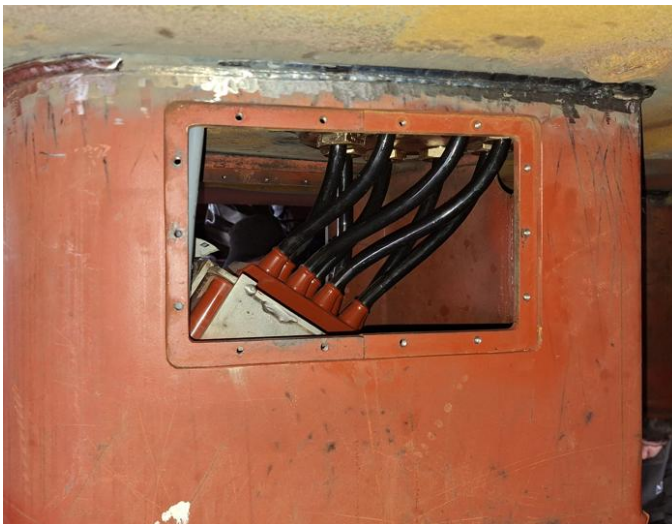
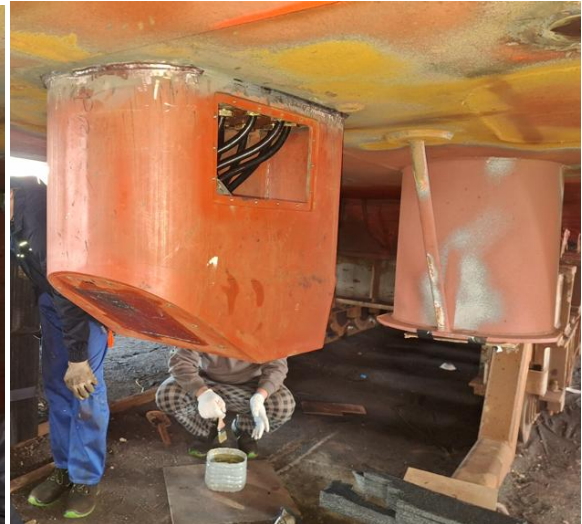
Blister installation

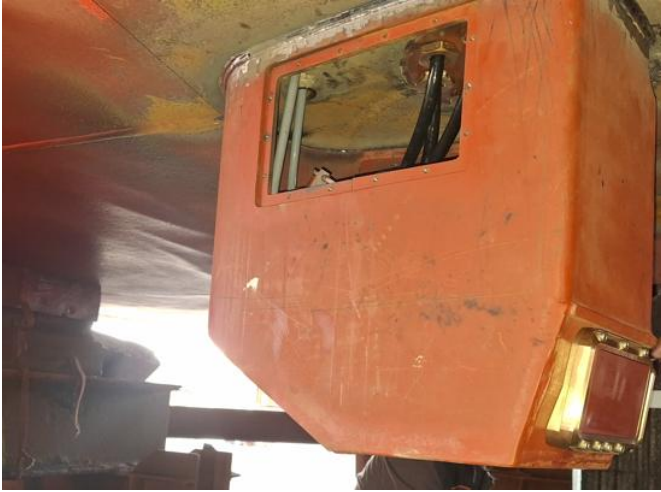
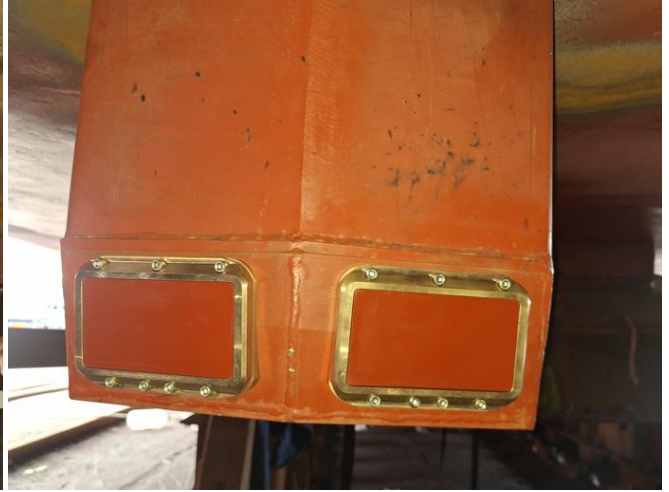
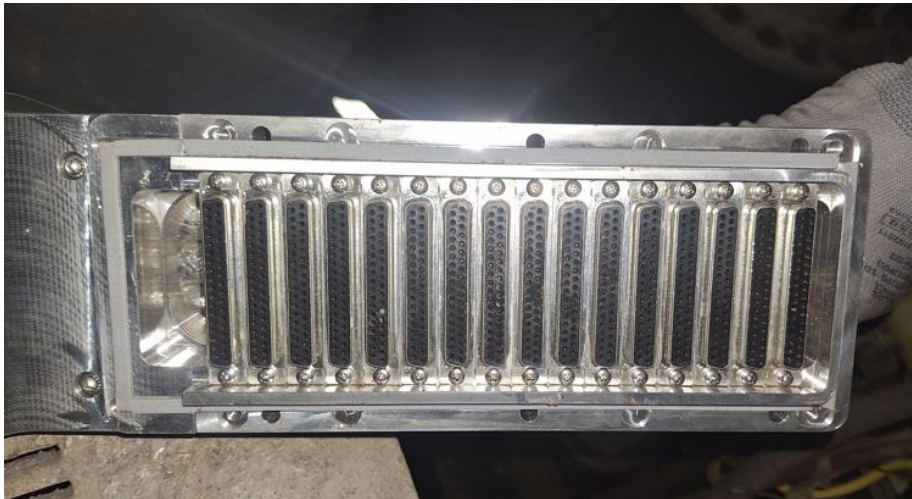
SN90 connector

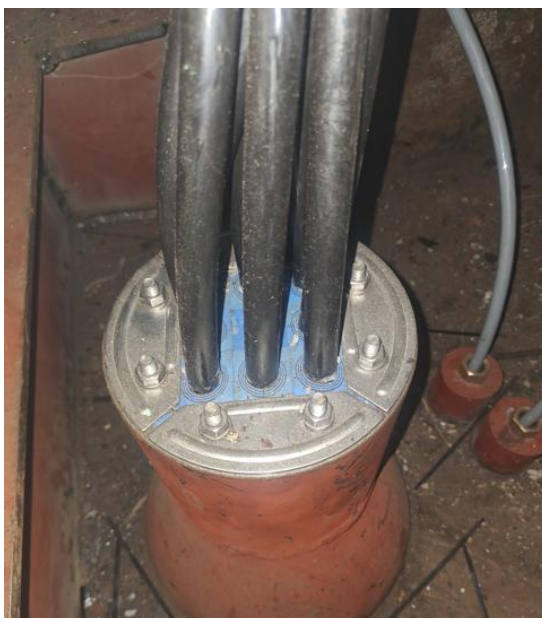
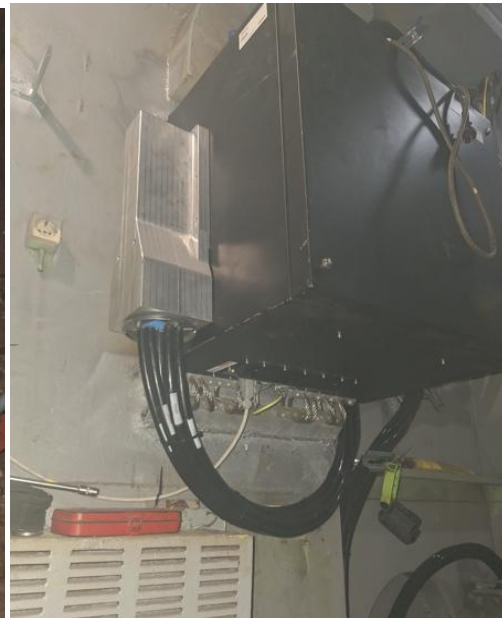
Roxtec and main connector

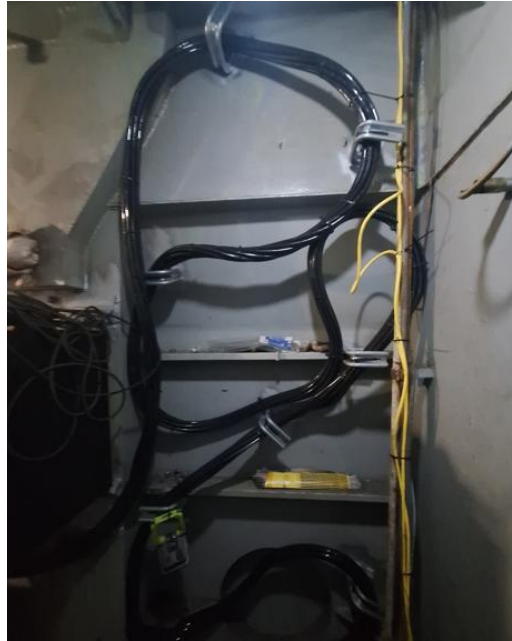
Cable layout

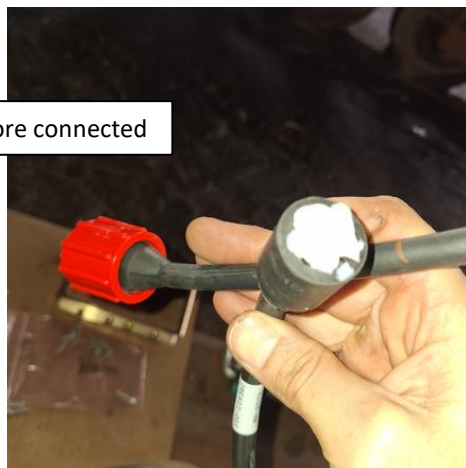
Molykote applied before connected

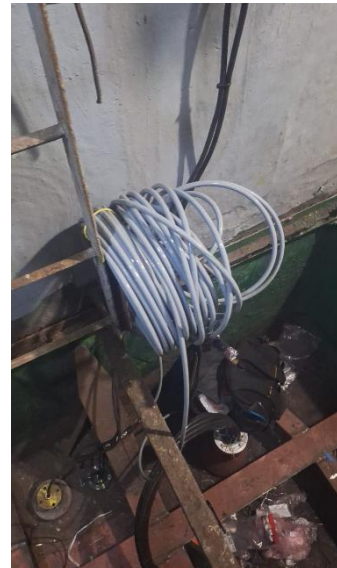
With SN90 transducer, 2 TP90 Hydrophones were installed. Receiver and computer will be installed in future. Cables were left into sonar room. We recommend to the crew to cover it in a proper way.

Hydrophone and cables

-Protect TP90 hydrophones cables.

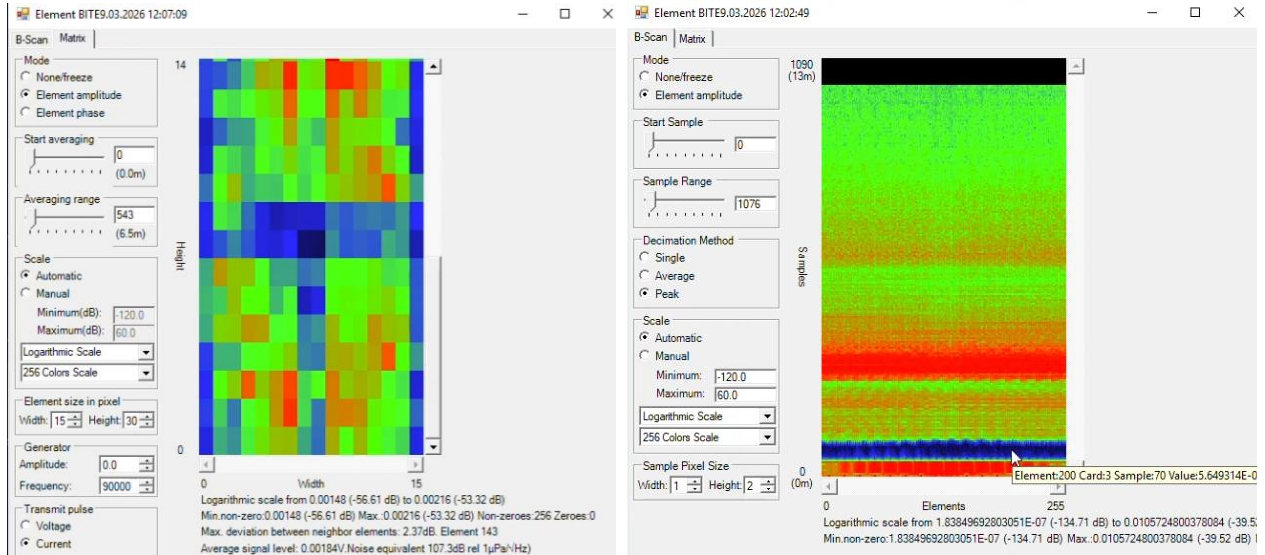
Matrix and bite

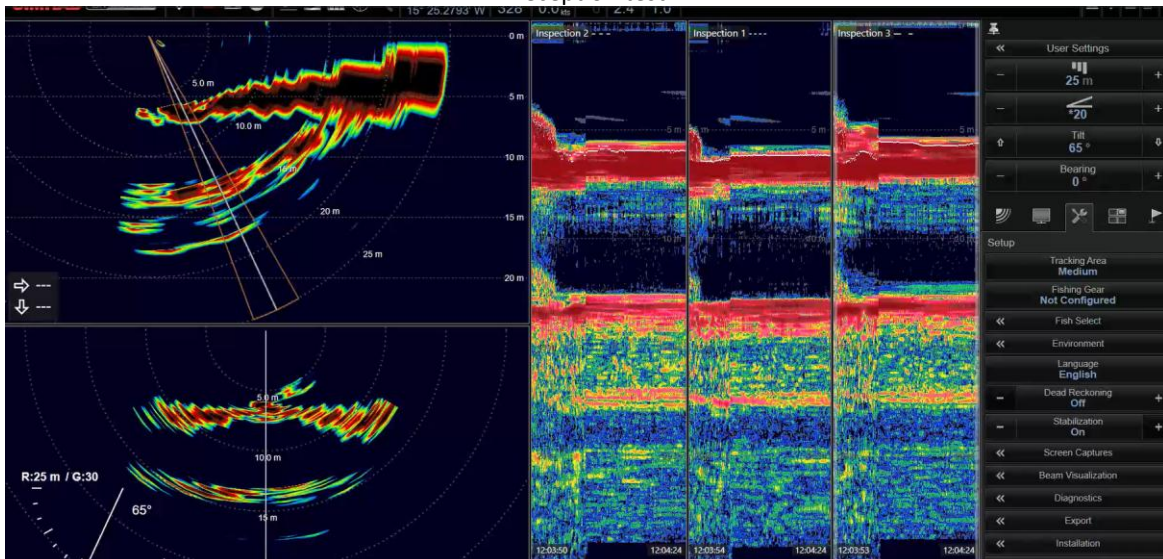
System working on port

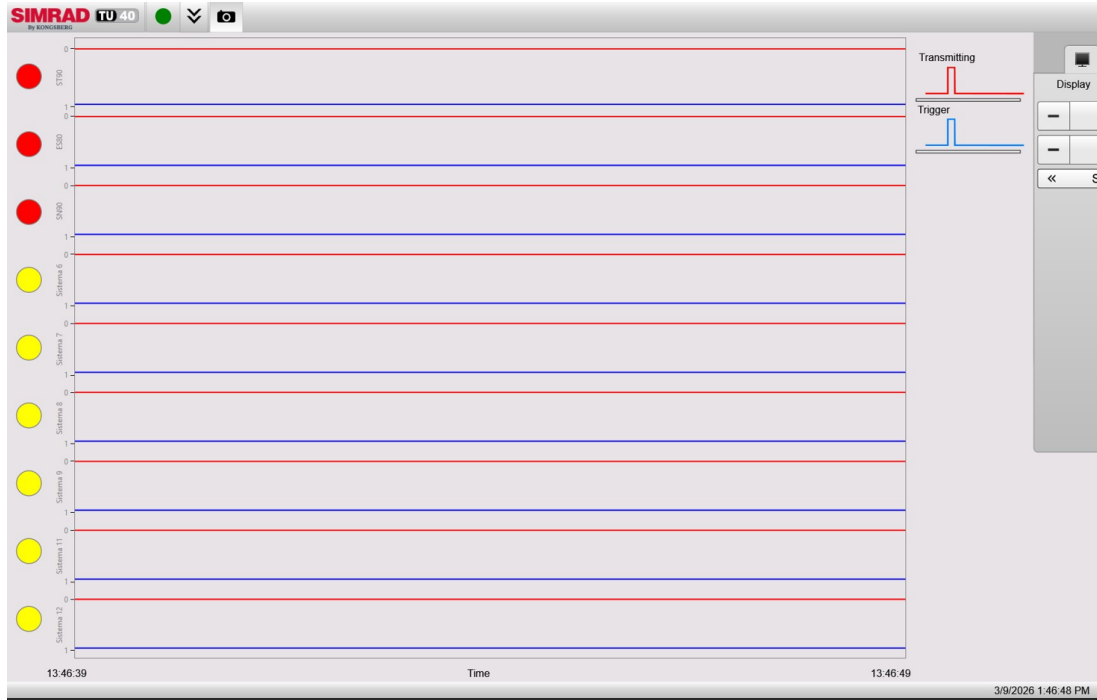
TU40 setup done.

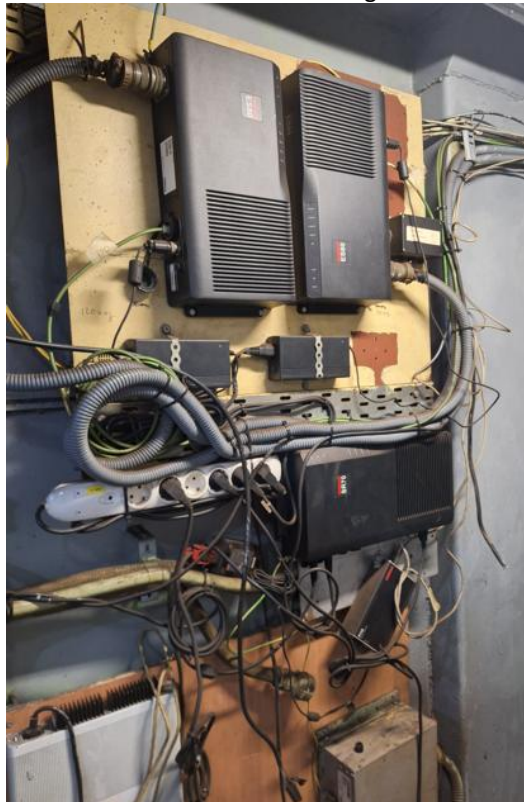
Distribution of system in sonar room

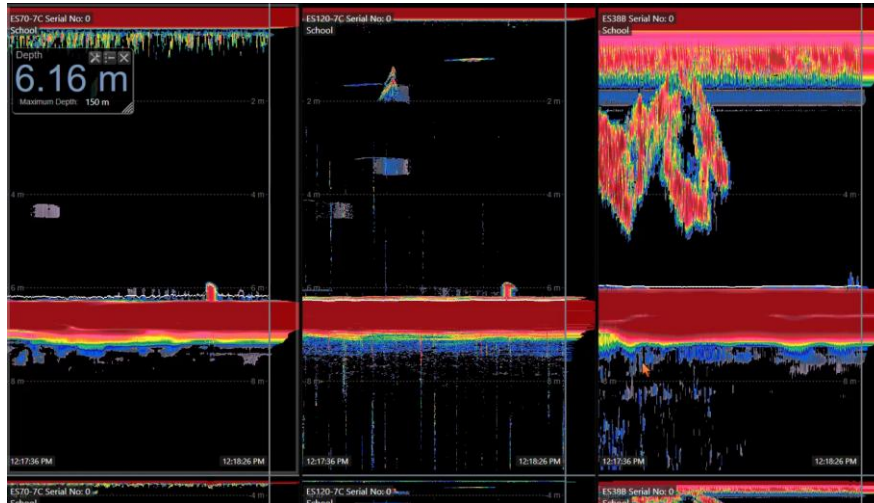
System working on port

-Serial ports not working.
